Uretara Catchment Restoration by Community Action

Monitoring summary 2008 to 2012

Uretara Catchment Restoration Project

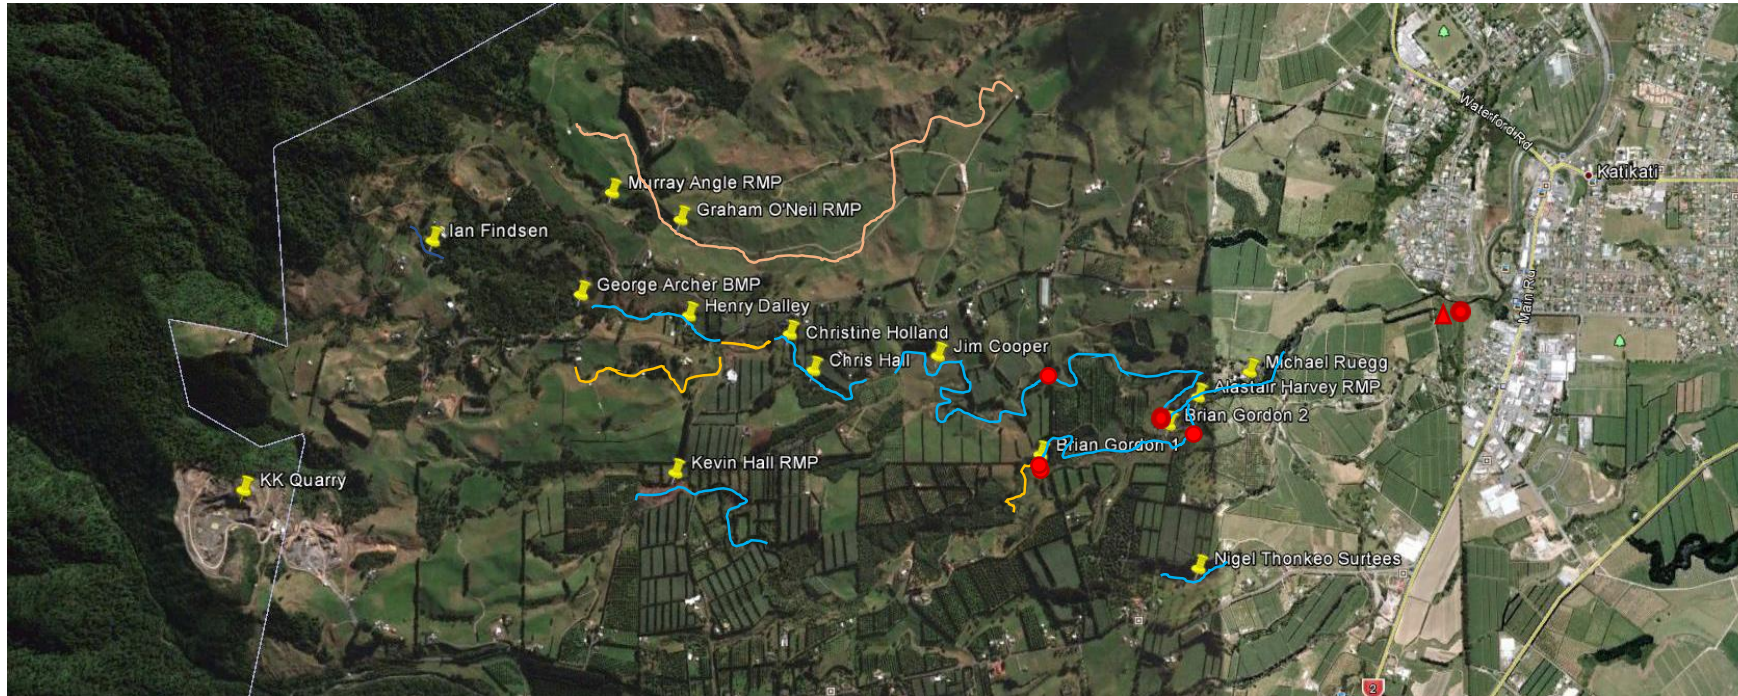
Uretara Catchment Project and Monitoring Sites

Project sites 2008-2012

Monitoring sites 2008-2012

Monitoring activities were carried out by UEM, KK College and BOPP over the course of the project to gather baseline information so long-term trends could be determined. Significant studies have also been conducted by BOPP graduates on freshwater fish and macroinvertebrate abundance and diversity, suspended sediment v stream flow, and a recently completed (June 2012) catchment ground-truth survey completed by BOPRC has provided useful information about riparian condition including bank erosion.

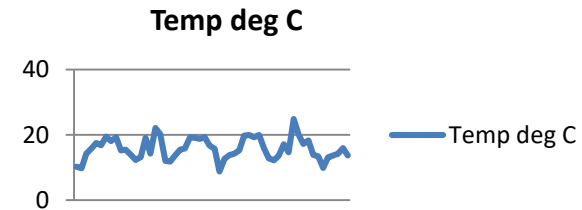
Bay of Plenty Regional Council

Date	Uretara site	Temp	Turbidity NTU	Sus solids g/m ³	Land Use
May -11	Henry Rd	16	2.1	4.4	Horticulture/Pasture
June -11	Henry Rd	13.7	1	0.89	Horticulture/Pasture

UEM has been provided with BOPRC data gathered from 2001. Most parameters score within an acceptable (non-trigger value) range, such as DO, pH, TN, TP and bacteria but temperature and suspended solids are often outside recommended guideline values. We intend to work more closely with BOPRC over coming years to supplement their data gathering process, which is relatively infrequent and not focused on the periods when various stressors are likely to be greatest (such as mid-summer water temperatures, suspended sediment levels in high flows).

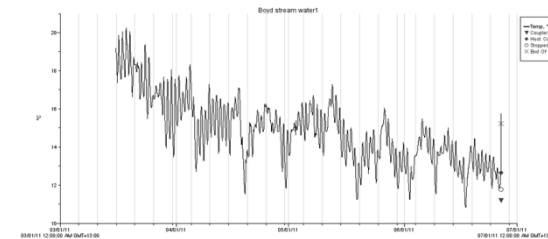
Date	Location	Temp	Clarity m	Flow m/s	Land Use
March -12	Quarry Qs1	17.3°C	0.88	0.1	Horticulture/Pasture
March -12	Boyd Bs1	14.8°C	1.5	0.1	Horticulture/Pasture

Katikati College students work in small groups and are closely supervised during the data gathering process. Back in class data is scrutinised and discussed, outlier values discarded (if found to be inaccurate) and group data averaged. The four surveys conducted by senior students each March on three separate occasions provides a useful insight into water quality and can be used to track trends.

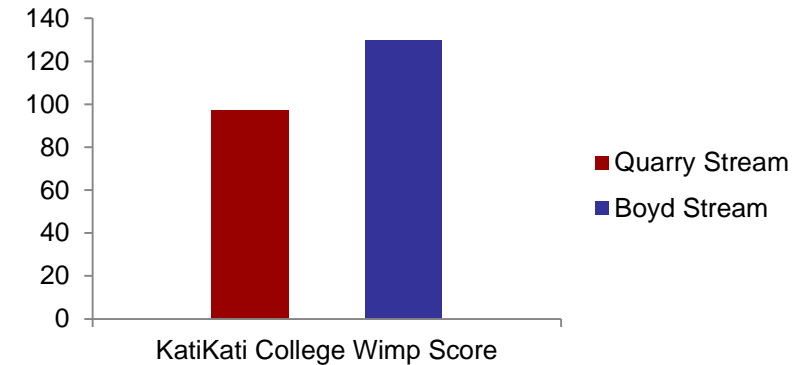
2.2 cont'd Katikati College macroinvertebrate surveys March 2009-12 (average scores)

Macroinvertebrate	Boyd	Quarry	Uretara (at BOPRC site)
Mayfly	28	4	28
Stoneflies	0	0	1
Cased Caddis	40	10	12
Free living Caddis	34	2	70
Dobsonflies	6	6	2
Snails	46	0	18
Dipteran	4	0	14
Shrimp	4	2	2
Damselflies	0	2	0
Leeches	0	2	0
Worms	34	8	16
Total number	196	36	163

Average WIMP scores in the two streams are quite similar (130 Boyd, 97 Quarry) but the macroinvertebrate populations within each catchment are significantly different. Both sets of data reflect the generally poor habitat within the two catchments and the severe impact of quarry operations on the Quarry catchment.

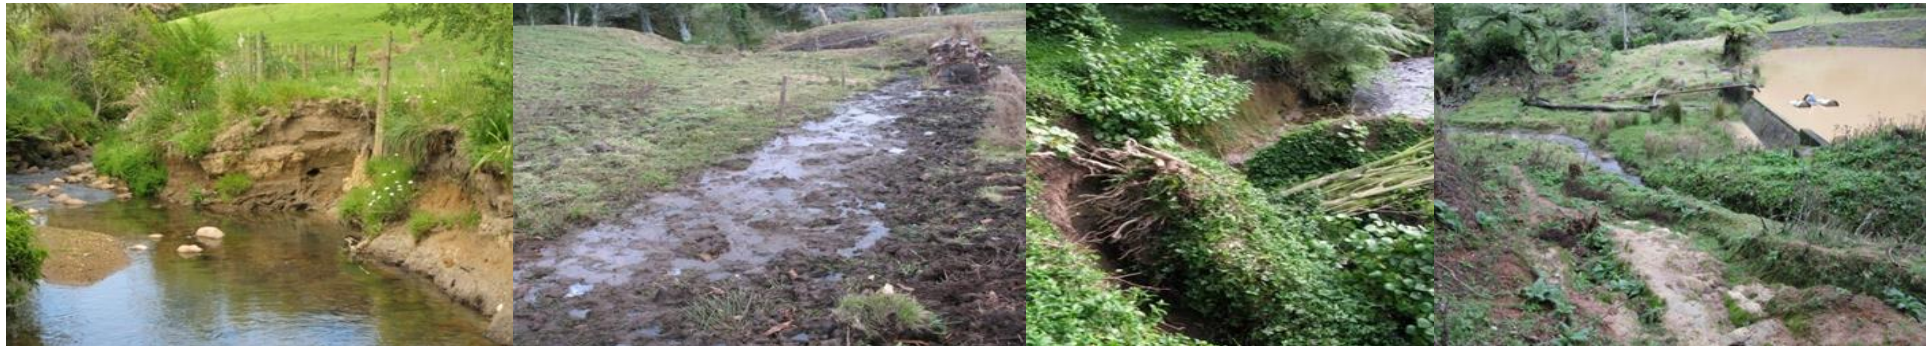
The photos below show some of the sediment sources we have tackled over the last four years and all have been significantly reduced through retirement, planting and bank regrading where necessary. KK Quarry Ltd has been under the spotlight too and has just completed an 18 point sediment management improvement plan under the direction of BOPRC. UEM have been invited to visit the site in July to see what has changed.

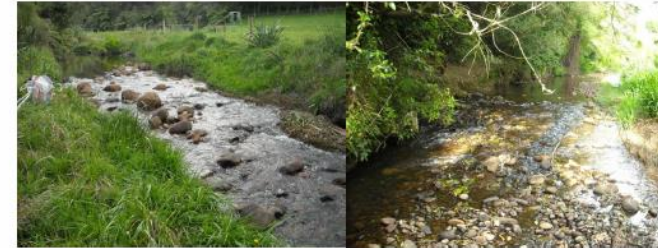
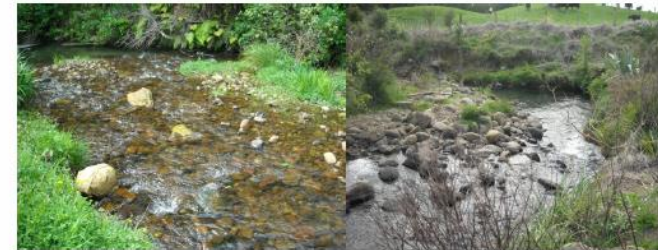
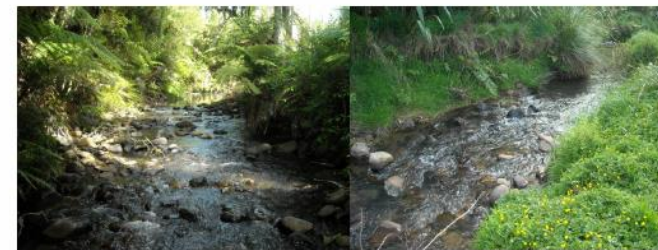
Photos: Boyd and Quarry stream study sites (Photos by Brendon Barnett).

Boyd site 1

Boyd site 2

Boyd site 3

Quarry site 1

Quarry site 2

Quarry site 3
